1 2 3 4 5 6 UNITED STATES DISTRICT COURT FOR THE WESTERN DISTRICT OF WASHINGTON 7 AT SEATTLE **MEG PAULSEN** 8 NO. 9 Ms. Paulsen, **COMPLAINT FOR DECLARATORY** v. AND INJUNCTIVE RELIEF 10 ASHWOOD COMMONS NORTH LLC, a 11 **Washington Corporation** 12 Defendant. 13 14 15 Plaintiff Meg Paulsen, by and through her attorneys Conrad Reynoldson and Marielle 16 Maxwell of Washington Civil & Disability Advocate brings this Complaint against Defendant 17 Ashwood Commons North LLC ("Defendant") to remedy unlawful discrimination on the basis 18 of disability and to seek injunctive and to seek injunctive and other equitable relief. 19 I. **OVERVIEW** 20 1.1 This is an action under the Americans with Disabilities Act (ADA) and the 21 Washington Law Against Discrimination (WLAD) to correct unlawful and discriminatory 22 practices against members of the public with disabilities who visit the parking garage and 23 businesses served by the parking garage owned by the Defendant, Ashwood Commons North Complaint for Declaratory and Injunctive Relief - 1

# **Features of the Elements Garage**

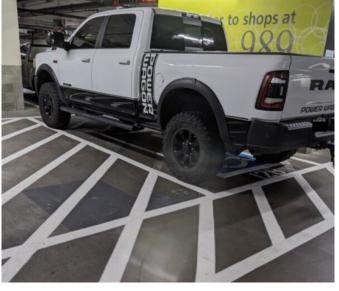
4.48 The space numbered 128 is identified as accessible by a sign that is mounted on the wall in front of the access aisle, not the space. The bottom edge of the sign is less than 60 inches from the finish floor of the garage. A pole is located within the access aisle that serves the space. The space itself is not located on the shortest accessible route. A person with a disability parking in this space has to go around the entire backside of the space and around the freight elevator to reach the elevator to the retail shops and businesses. Further, this striped route from the access aisle is obstructed by larger vehicles when they are parked in the space, and by a garbage can that is placed

in the accessible route. Recent photographs of the space and the striped designated accessible route are included below.

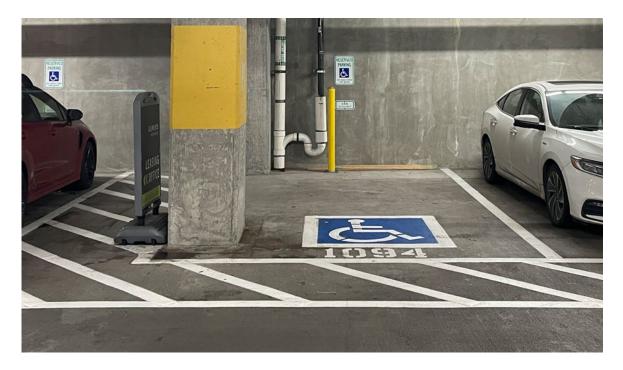
4.51 The space numbered 1094 is identified as accessible by a sign. The space has a second sign below the sign designating that space that states the space is "Van Accessible". The sign designating the space is less than 60 inches from the finish floor, and the secondary "Van Accessible" sign is located even farther down the wall. The "Van Accessible" is fully obscured by any vehicle parking in the space, even vehicles with very low clearance. The space has both a pillar located within it that obstructs the space and makes it impermissibly narrow for a "Van Accessible" designated space, and it also has a pole located within the space at the head of the space. The access aisle serving the space is less than 60 inches in width. The leasing office routinely places a sign in the access aisle that obstructs the aisle. The space is not located on the shortest accessible route to the elevator for the retail shops but is across from a residential elevator. A recent photograph of the space is included below.

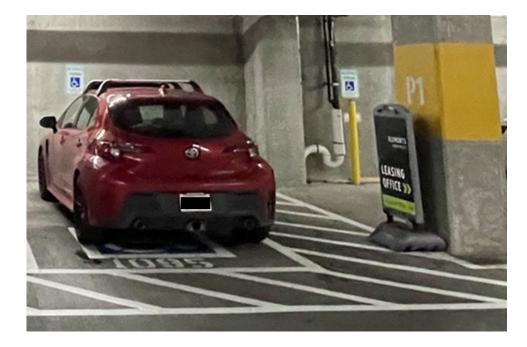
4.52 The space numbered 1095 is identified as accessible by a sign. The space has a second sign below the sign designating that space that states the space is "Van Accessible". The sign designating the space is less than 60 inches from the finish floor, and the secondary "Van Accessible" sign is located even farther down the wall. The "Van Accessible" is fully obscured by any vehicle parking in the space, even vehicles with very low clearance. Space 1095 shares an access aisle with Space 1094, so it has the same issues with both the accessible route, the insufficient access aisle width, and the sign occasionally placed in the access aisle. The space is of insufficient width for a compliant "Van Accessible" space. The leasing office routinely places a sign in the access aisle that obstructs the aisle. A recent photograph of the space is included below.

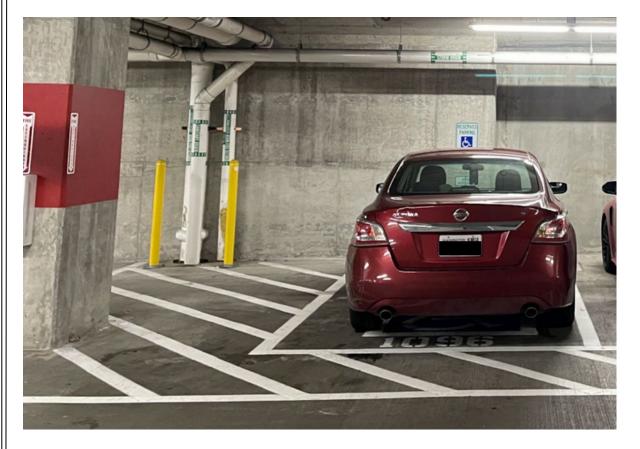
4.53 The space numbered 1096 is identified as accessible by a sign. The space has a second sign below the sign designating that space that states the space is "Van Accessible". The sign designating the space is less than 60 inches from the finish floor, and the secondary "Van Accessible" sign is located even farther down the wall. The "Van Accessible" is fully obscured by any vehicle parking in the space, even vehicles with very low clearance. Space 1096 is located directly to the left of Space 1095, so it shares the same issues with accessible routes. The space is of insufficient width for a compliant "Van Accessible" space as it is only the width of a standard accessible space with an access aisle serving the space that is less than 60 inches in width due to the pillar located within the access aisle. There are also additional poles located within the access aisle. A recent photograph of the space is included below.

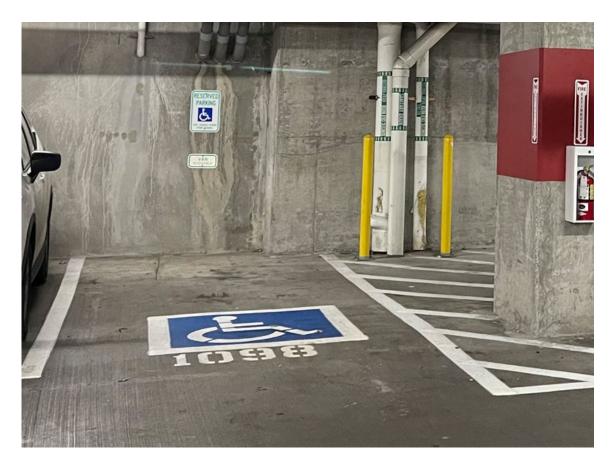
4.54 The space numbered 1098 is identified as accessible by a sign. The space has a second sign below the sign designating that space that states the space is "Van Accessible". The sign designating the space is less than 60 inches from the finish floor, and the secondary "Van Accessible" sign is located even farther down the wall. The "Van Accessible" would be obscured by any vehicle parking in the space, even vehicles with very low clearance. Space 1098 is located directly to the left of Space 1096, so it shares the same issues with accessible routes. The space is of insufficient width for a compliant "Van Accessible" space as it is only the width of a standard accessible space with an access aisle serving the space that is significantly less than 60 inches in width due to the pillar located within the access aisle. There are also additional poles located within the access aisle. The construction of the space is strange as the wall juts out on the right side of the head of the space. A recent photograph of the space is included below.

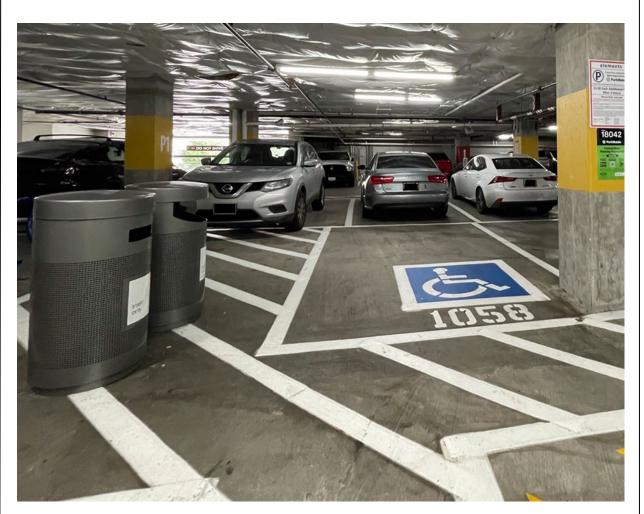
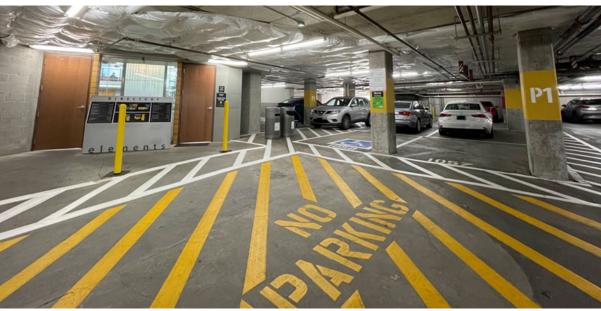
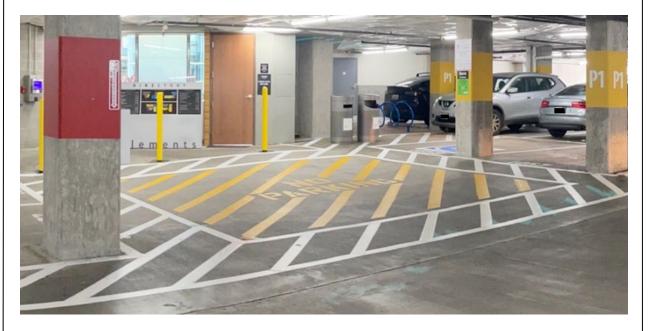
4.55 The space numbered 1058 has no signage designating the space as accessible. The width of the space has a pillar located within the marked boundaries of the space. The access aisle serving the space routinely has garbage cans placed in it that impermissibly narrow and obstruct the aisle. There are changes in level within the space that are greater than the maximum slope allowable by the ADA Standards. Further, the placement of the space itself, while it is close to the elevators that offer access to the retail shops, is difficult to access. Entering the "accessible" space requires either driving through the spaces of other cars or narrowly entering through a marked no-parking area. Parked Cars can obstruct the access aisle as seen in the recent photographs below. It is impossible to pull into one side of the space when cars are parked behind it, and it is unclear from the striping that entering the space through the "no parking" striped area is even allowable. Recent photographs of the space are included below.

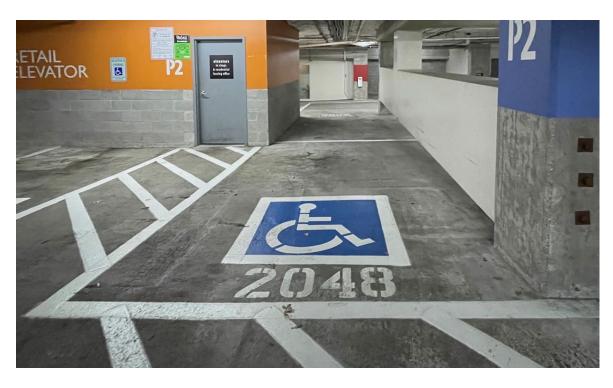
4.56 The space numbered 2048 has no signage designating the space as accessible. The space has a corner of the building that encroaches into the head and the foot of the space. The access aisle serving the space narrows to less than 60 inches in width at the head of the space where it connects to the door to the retail shops' elevator. There are changes in level within the space and the access aisle that are far greater than the maximum slope allowable by the ADA Standards. The door leading to the retail shops elevator requires much greater opening force than is allowable by the ADA Standards. A recent photograph of the space is included below.

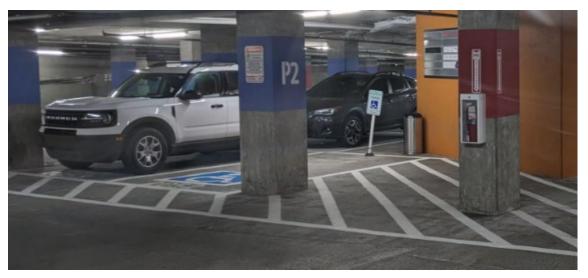
4.58 The space numbered 2052 has a sign designating the space as accessible. The sign designating the space is well below 60 inches from the finish floor, any vehicle parked directly in the space would fully obscure the sign. The access aisle serving the space on the right side has a pillar located within the aisle that obstructs the aisle as well as the corner of the building encroaching into the aisle at the head of the space. The pillar within the aisle causes the aisle to be nigh-unusable with some patrons choosing to park in such a way that they take up multiple spaces in order to safely exit their vehicle. There are changes in level within the space and the access aisle on the left side that are far greater than the maximum slope allowable by the ADA Standards. Recent photographs of the space are included below.

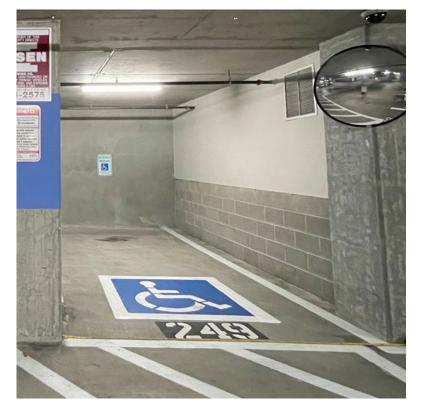
4.59 The space numbered 249 has a sign designating the space as accessible. The sign designating the space is below 60 inches from the finish floor and would be obscured by a parked car. A pillar is located within both the space and the adjacent access aisle at the left foot of the space that obstructs both the space and access aisle. Due to the pillar, the space is of insufficient width under the ADA Standards. The space is not located on the shortest accessible route to an accessible entrance. A recent photograph of the space is included below.
